# Manhole Inspection Summary

Manhole # S29CC2047MH

**Location** Address: **5514 KEMPER RD**

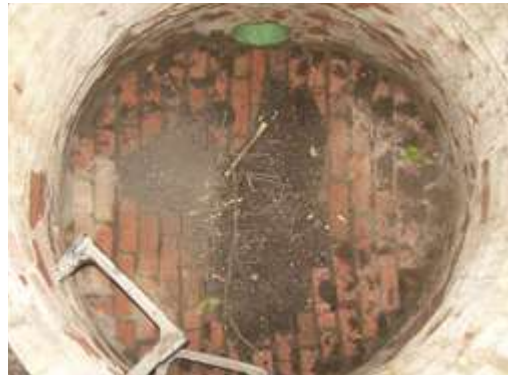
Top View

Channel debris.

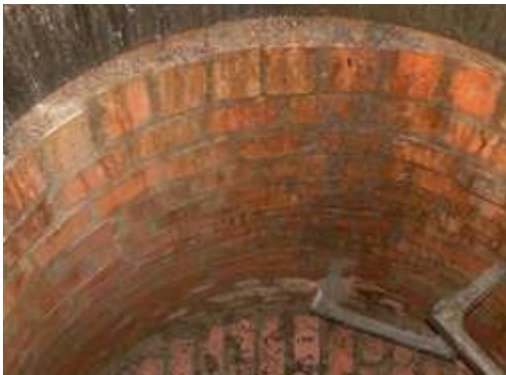
Defect

Frame offset. Adjustment infiltration.

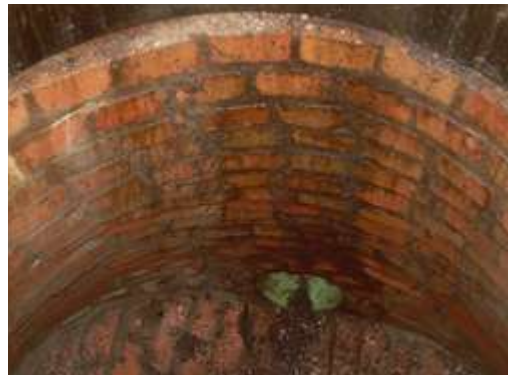
Defect

Frame offset. Adjustment infiltration - other side.
